Missoula County Conservation District

**CLARK FORK RIVER
IRRIGATION DIVERSIONS PROJECT
FINAL REPORT**

**December 1995
P11372.00**

**Prepared by
Acres International Limited
Suite 500, 10201 Southport Road S.W.
Calgary, Alberta
T2W 4X9**

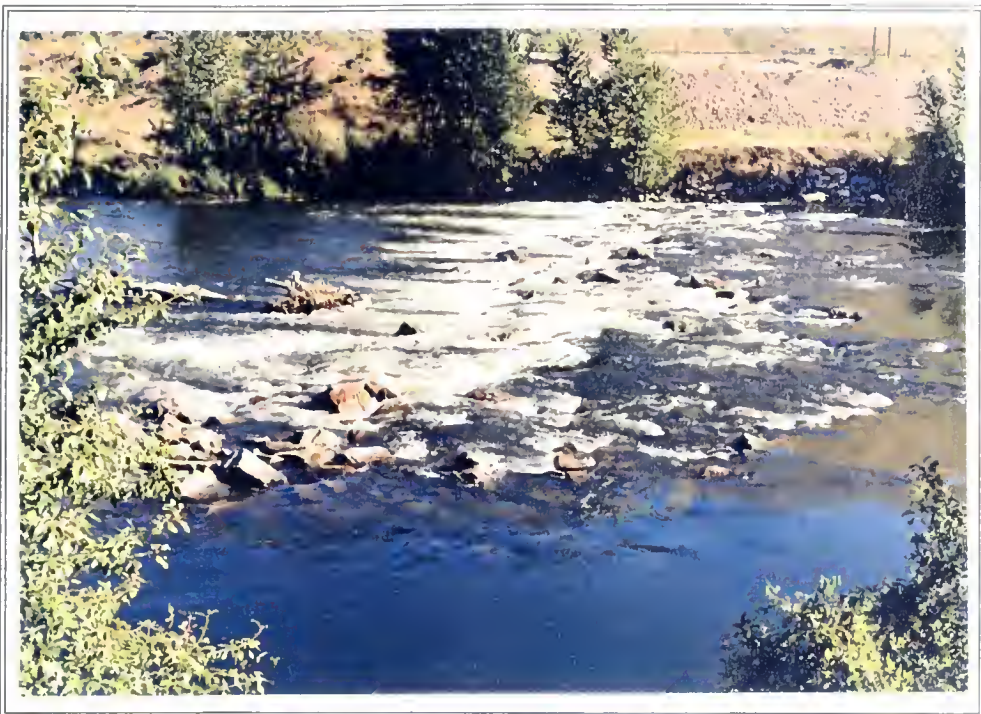
As noted in Section 2.2, the existing rock diversion structure is in good condition. There is some erosion on the bank of the approach channel near the intake structure and the rubble overflow weir or "blow-out" near the bypass structure exhibits significant leakage.

Missoula Irrigation District - Irrigation Diversion Structure

Bank erosion near the intake structure should be repaired with riprap or gabion erosion protection.

The higher earthfill embankment is the recommended alternative based on aesthetics, recreational opportunities, safety and costs.

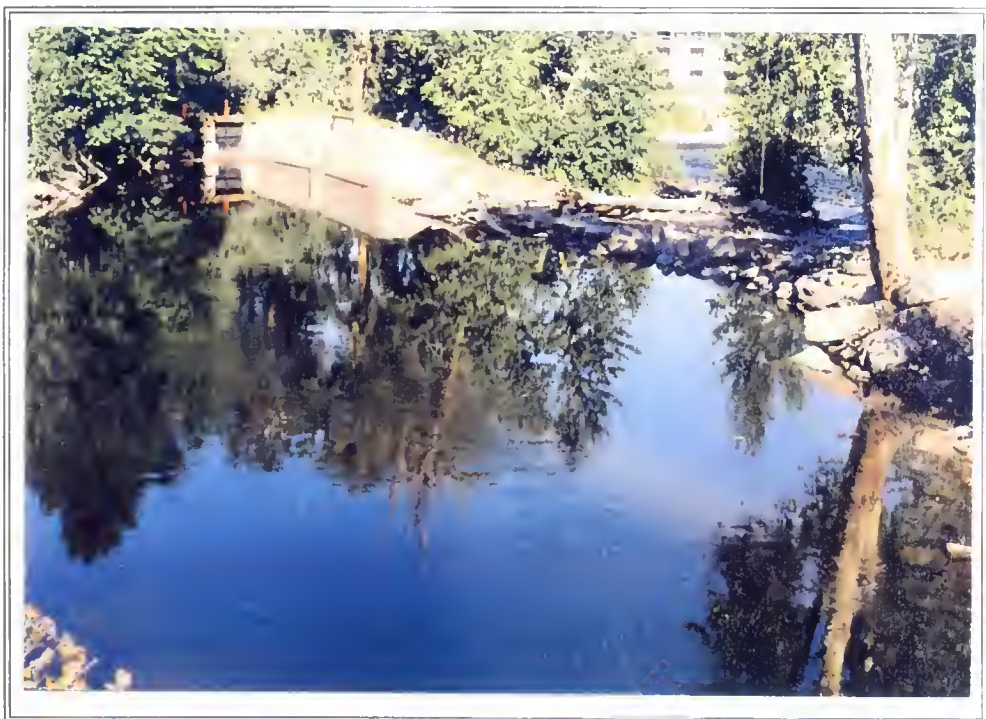
While no claims or law suits have been filed, there are a number of possible liability concerns which need to be addressed. Of particular concern is the open sluiceway below the stop boards of the bypass structure. At high water levels, the speed and volume of water here is a potential hazard since there is no grate, railing or enclosure to prevent anyone from slipping off the walkway and being quickly swept into the main river channel.

Missoula Irrigation District - Intake and Bypass Structures

Due to the heavy recreational use, there are a number of improvements which should be considered at this site. While some are aesthetic, many are critical to the safety of the public using this area. At a minimum, it is recommended that grates be placed over the two large openings in the by-pass structure. Also, an attractive hand rail system should be installed along the leading edge of the structure, especially over and around the stop boards.

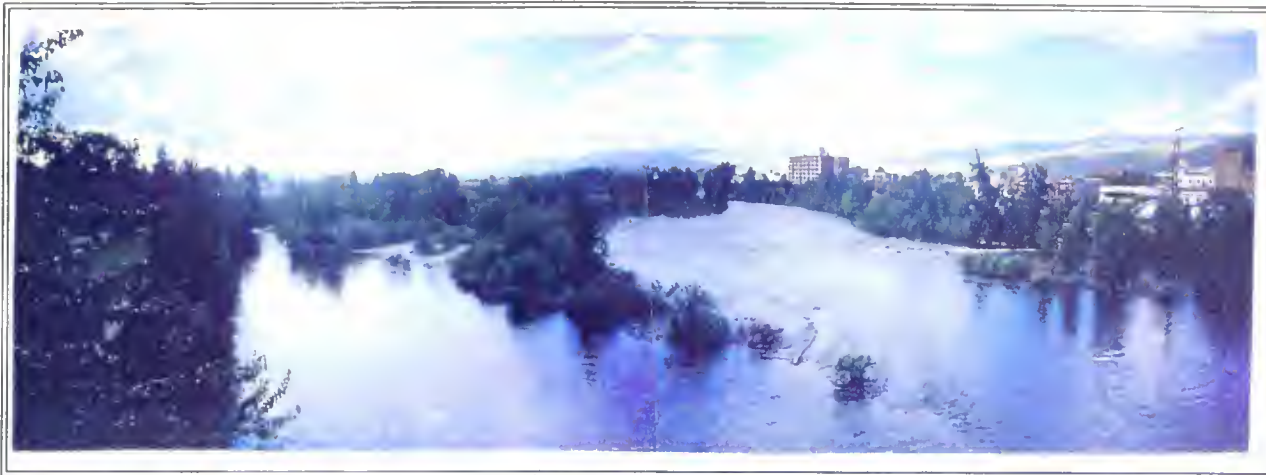
The Orchard Homes Irrigation Company's diversion system consists of a damaged timber floor irrigation diversion structure across part of the Clark Fork River, an existing rock groin and 750 ft. long approach channel along the left bank of the river, an intake structure with one vertical gate and a bypass structure to convey excess flows back to the river.

This diversion raises several aesthetic and liability concerns. The most obvious is the presence of the remainder of the original diversion structure directly opposite Caras Park on the north bank. Nearly every person contacted in this investigation commented about the appearance and hazard of this structure. There are protruding sections of concrete rubble and steel bars which could cause serious injury to unsuspecting boaters, since they are not readily visible at high water. Since the value of this structure to the diversion is questionable, a program of either complete removal (over a reasonable time period) or removal of the most dangerous portions should be seriously explored so as to reduce liability exposure to the company and District.

Orchard Homes Irrigation Company
Irrigation Diversion and Approach Channel

The rockfill structure is the recommended alternative based on costs.

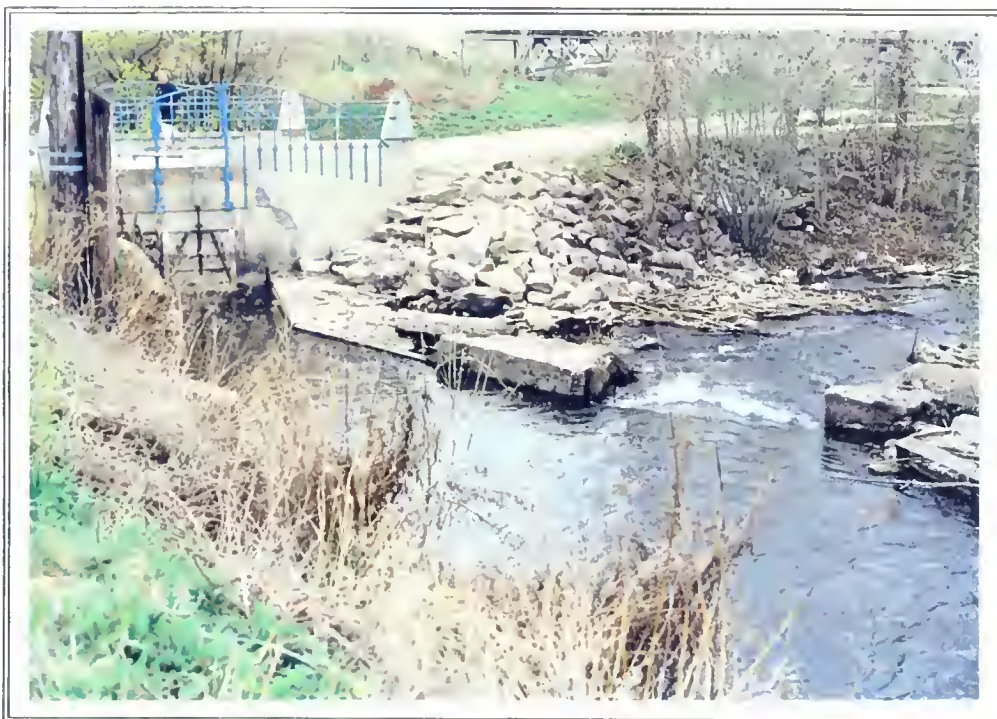
The intake and bypass structures for the canal are directly in front of Eagle Watch Estates, a seniors residential facility. While the structure is large, it is in fairly good repair and not unattractive, given its relationship to the bank and most readily accessible viewpoints. Currently, the amount of water being released from the bypass back into the river creates quite a scene. The rushing water sound from this structure can be heard for a considerable distance. The stream of white water gushes straight out from the structure into a relatively calm lake or afterbay which is separated from the main river by another island. According to Mr. Badenoch, some of the residents of Eagle Watch want improved access to this point. As noted above, MRA has not rejected this idea and such an idea should be considered.

Orchard Homes Irrigation Company
Intake and Bypass Structures

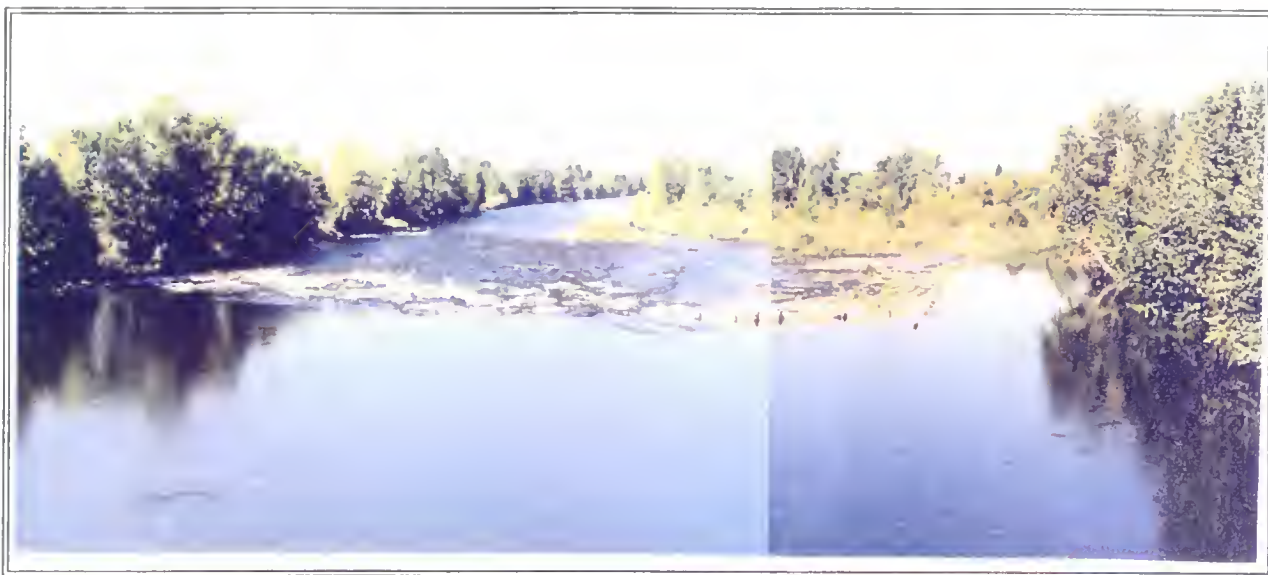
As noted in the site reconnaissance, the existing concrete intake and bypass structures are in good condition. There is a minor "blowout" along the approach channel and the diversion structure and rock groin have been repaired frequently to improve irrigation diversion during low river discharges.

The general aesthetic aspects of this diversion have already been touched upon. While the diversion structure in the river is quite obvious and obtrusive, it is not blatantly ugly. That it completely spans the river makes it particularly obvious. It is most obtrusive at the north (near) end where large boulders protrude to form the corner of the structure. Since the river descends fairly rapidly here, the structure's presence creates white water for some distance downstream. While its presence creates some hazard to boaters and rafters, it is not so critical here as with the Caras Park structure since its existence is fairly obvious. As noted above, any changes or improvements here will have to be extremely sensitive to the area's high visibility.

Hellgate Irrigation Company
Irrigation Diversion Structure

An earthen dike with a crest elevation of about elevation 3,167 ft. should be constructed across the "blowout". The groin running parallel to the flow should be built to the same elevation. The groin, dike and much of the surrounding ground on the island would be subject to overtopping by a flood of greater than 21,000 cfs. A flood of this magnitude is likely to occur at a frequency of about 1 in 5 years. The damaged sections of the groin or dike would then require repair. To prevent frequent overtopping a dike along most of the length of the approach channel would be required. The district should assess the overall merits of increasing the height of the dike.

Adding to the rockfill structure is the recommended alternative based on costs.

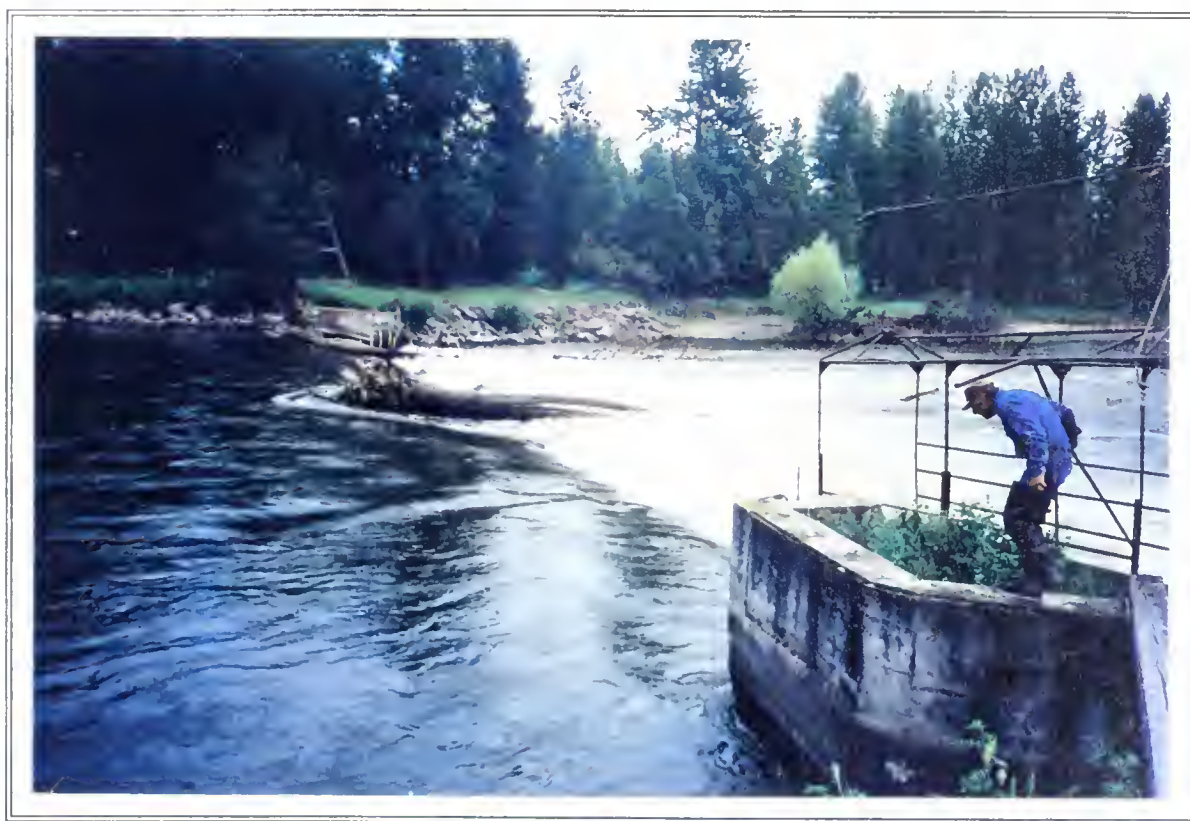
The most recent damage occurred in the fall of 1994, when bed material was removed from beneath the timber floor and downstream of the structure in a localized area. Although the decking remained intact, significant flow was conveyed beneath the timber decking via the eroded area. Angular riprap ranging in size from 5-6 feet was placed in the damaged area near the left abutment. Additional material is scheduled to be placed after high water this year. Similar damage occurred in 1972 near the right abutment but was not visible at the time of inspection.

This diversion site operates satisfactorily with some difficulty during low river flows. It has experienced some erosion downstream of the structure but this has generally been repaired. The installation of the timber stoplogs is difficult and is accomplished from a trolley suspended from a cable.

Grass Valley - French Ditch Irrigation Company
Irrigation Diversion Structure

Short term plans for the diversion facilities should include maintenance of the erosion protection of the river bed downstream and upstream of the timber floor. Diligent maintenance with large rock (minimum 3 ft. diameter) will prevent any future undercutting and damage to the timber floor. To improve the timber check installation procedure, the cable supporting the trolley should be tightened and a lightweight, non-slip grating should be installed as the trolley floor.

The timber floor is the recommended alternative based on costs and past performance.

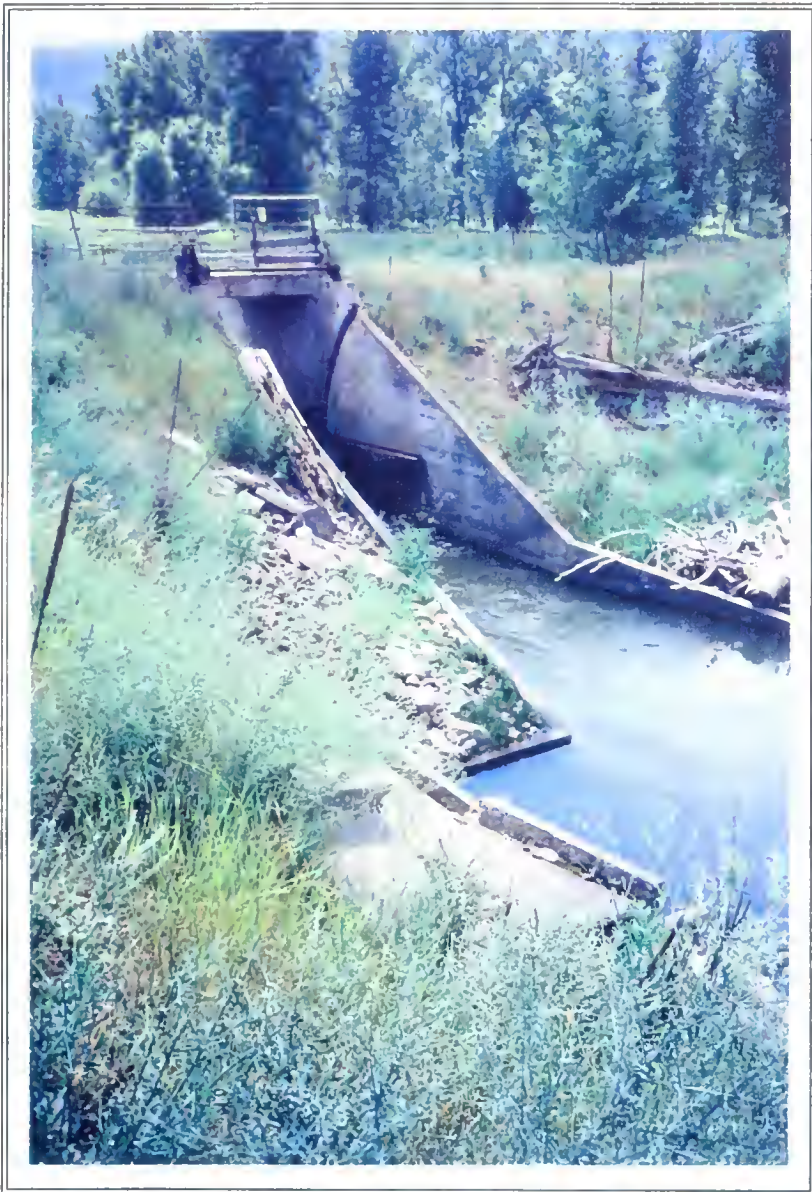
Frenchtown Irrigation District
Bypass Structure
